Exterior Stone Conservation Study

Independence National Historical Park
National Park Service
Department of the Interior

MERCHANT'S EXCHANGE BUILDING

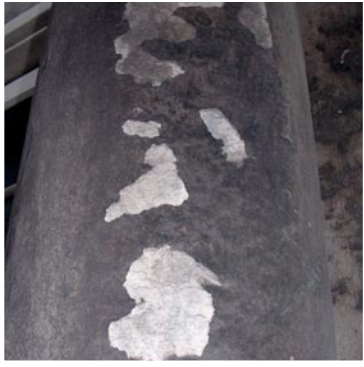
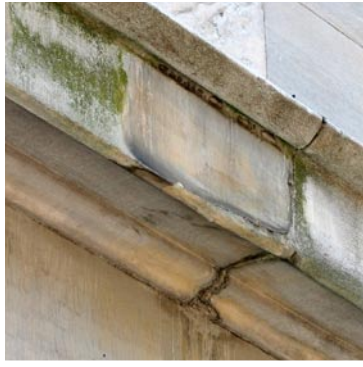
Stone Blistering (far left) and staining and microflora (right) are only two of the conditions which exist on the building.
